RRL REPORT NO. 3

VEHICLE IMPACT TESTS ON A HEDGE OF
ROSA MULTIFLORA JAPONICA

VEHICLE IMPACT TESTS ON A HEDGE OF ROSA MULTIFLORA JAPONICA

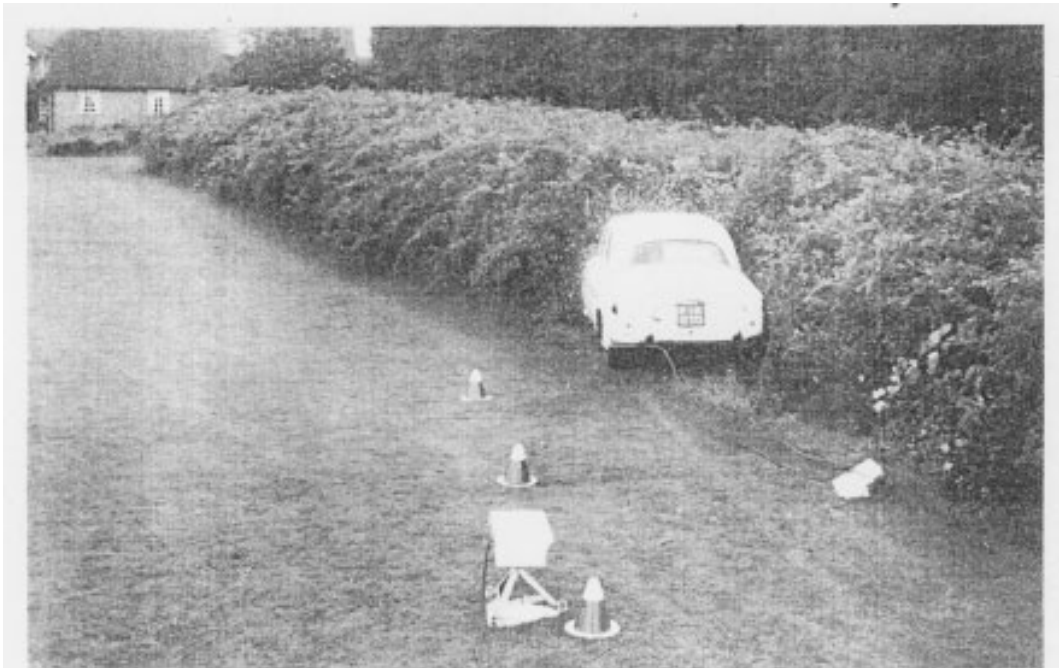
PLATE 1

Test car at start of impact with hedge
of *rosa multiflora Japonica*

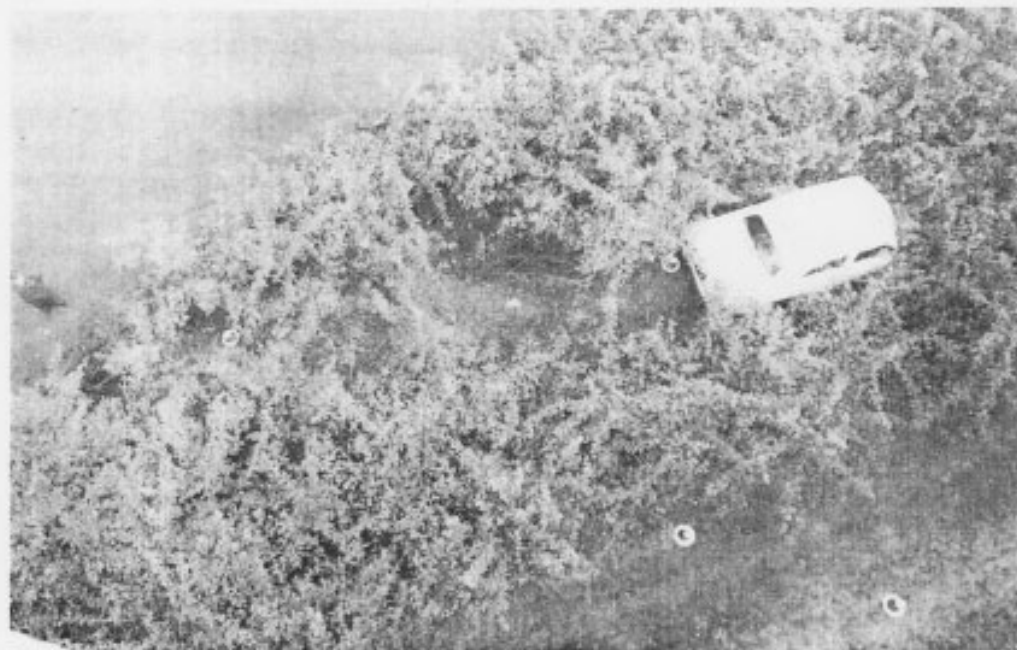
PLATE 2

Overhead view showing final position of test car
in hedge of *rosa multiflora Japonica*

In tests A and B the car passed completely through the hedge; in test C the car was stopped within the hedge. Films from the overhead cameras recorded the path of the vehicle within the hedge, but did not yield accurate speed data because of perspective distortion. The accelerometer records provided more reliable measurements of the motion of the car.
